# Manhole Inspection Summary

Manhole # S51A2\_010MH

Insp Date: **5/15/08 10:59 AM**

**Location** Address: **3550 Fairfield Rd.** Cross Street: **E.Patapsco Ave.**

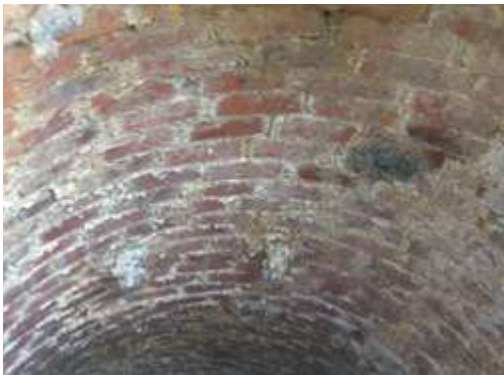
**Steps** Count: **0** Missing: **6** ☐ Corroded

Missing steps

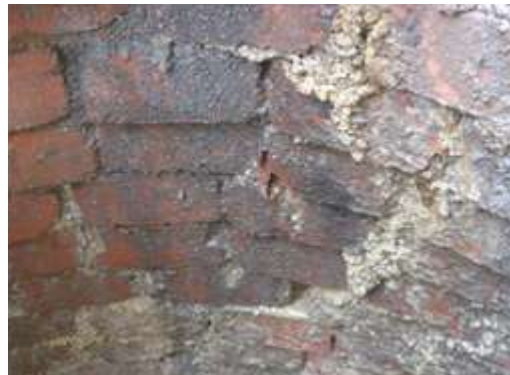
Defect 1

**Barrel** Material: **Brick** ☐ Parged  
Shape: **Circular** Diameter: **42** (in.) Length: (in.)  
Condition: ☐ Sound ☒ **Cracked** ☐ Root Intrusion ☐ Loose Brick ☐ Deteriorated  
Infiltration: ☐ None ☐ Joint ☒ **Cracks** ☐ Mortar ☐ Roots ☒ **Wall**

Crack and infiltration on the wall.

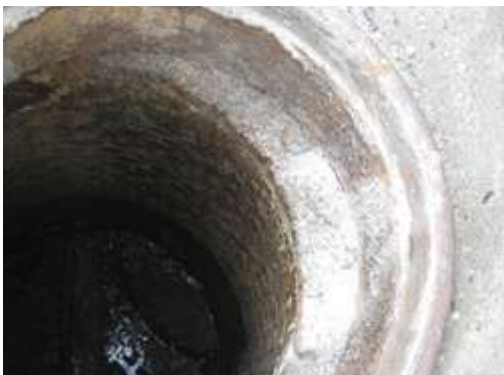
Defect 2

**Frame** Offset: **3** (in.) Condition: ☒ Sound ☐ Cracked ☐ Leaks

Frame offset

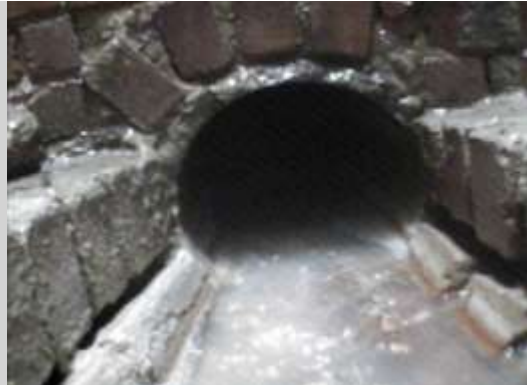
12 O'Clock Outflow

Pipe Height: **12** (in.) Rod and Bar (Angled)  
Pipe Material: **Clay** ☐ Pipe Lined  
Invert Depth: **11.68** (ft.) Flow Characteristics: **Fast**  
Deposits: ☒ None ☐ Mud ☐ Sludge ☐ Debris ☐ Grease  
Silt Depth: (in.) Deposits Extent:  
Infiltration: **None** Pipe Seal Cond: **Sound**

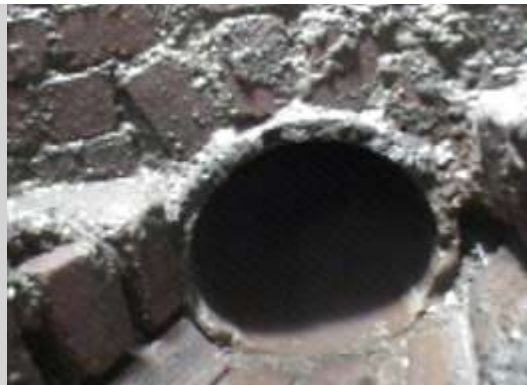
3 O'Clock Inflow

Pipe Height: **9.6** (in.) Rod and Bar (Angled)  
Pipe Material: **Clay** ☐ Pipe Lined  
Invert Depth: **11.56** (ft.) Flow Characteristics: **Slow**  
Deposits: ☒ None ☐ Mud ☐ Sludge ☐ Debris ☐ Grease  
Silt Depth: (in.) Deposits Extent:  
Infiltration: **None** Pipe Seal Cond: **Unknown**

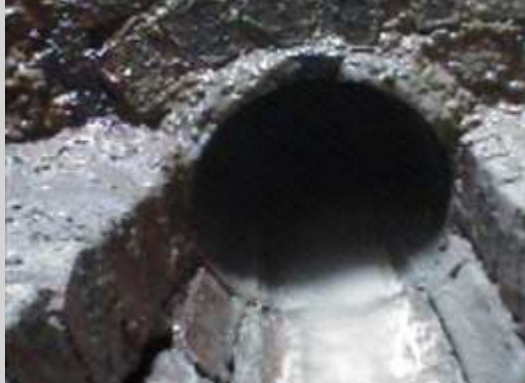
6 O'Clock Inflow

Pipe Height: **10.8** (in.) Rod and Bar (Angled)

Infiltration: **None** Pipe Seal Cond: **Unknown**
